University-Affiliated Spaceport Technology Development Contract

Development of Columbia Leading Edge Reconstruction System

April 20, 2004

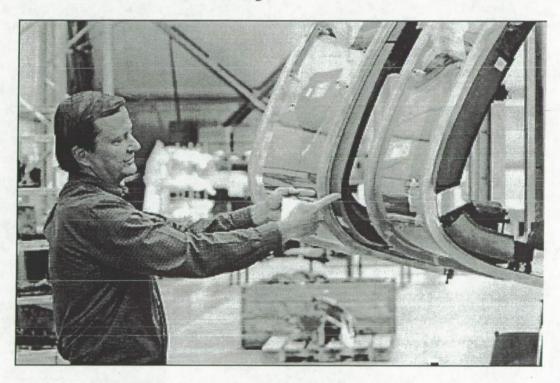
Figure 6 Inspectors Observing Recovered Leading Edge Components

The reconstruction of the left wing was instrumental in this analysis. Figures 6 and 7 show a portion of the recovered debris in the carrier frames. In a careful, frame-by-frame, analysis, investigators determined that the foam fell off the bipod area. As it tumbled at about 500 mph relative to the wing, it struck with a footprint about two feet in diameter. It struck the wing's leading edge panels number five, six and seven – a key area of the wing where it angles out less sharply. Investigators found that the left side leading-edge panels are more badly damaged than those on the right side. Steve Altemus, a NASA engineer overseeing the reconstruction, told the CAIB board that the panels on the left side also contained heavy deposits of melted metal. Panel number six, where the foam is believed to have struck is missing.
